CASE REPORTS

## Complications Associated With the Guide Wire in Percutaneous Transluminal Coronary Angioplasty

*(J Am Coll Cardiol 1987;10:218-21)*

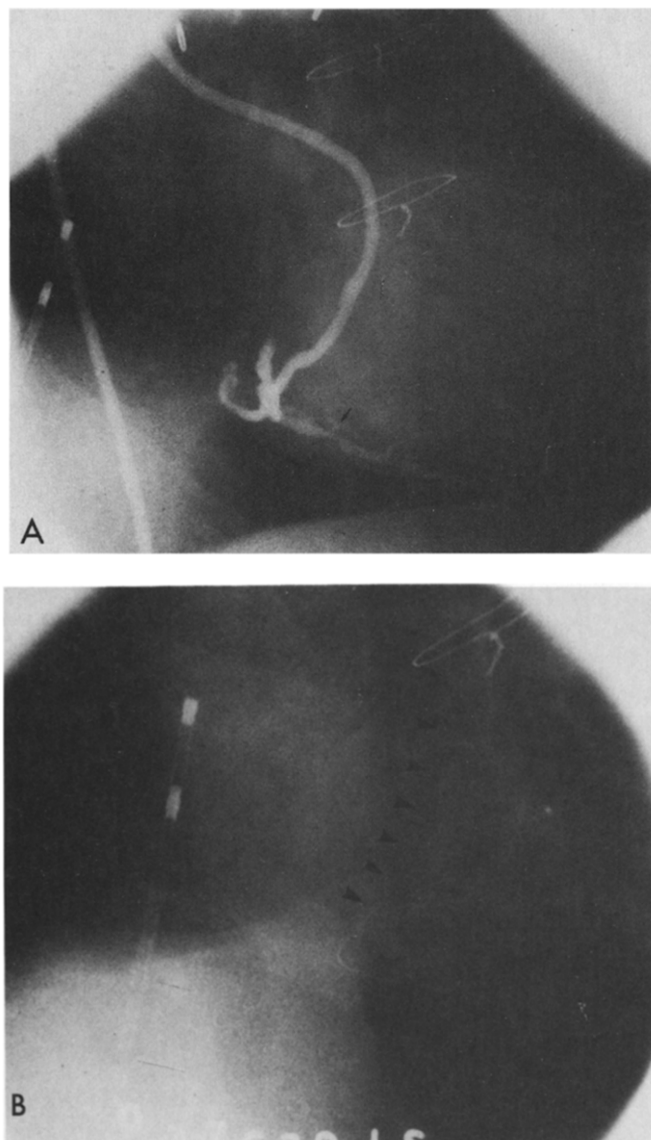
*removed*, it was noted that the distal 3 mm were intact but proximal to this point the single platinum coil had become unraveled (Fig. 2C). It was also observed that the forming ribbon had become detached from the distal tip weld. The end of the forming ribbon and the distal solder joint are shown in Figure 3.

The guide wires used in our three cases were USCI 0.014 inch flexible steerable J wires (Fig. 3). The total length of the wire is 175 cm long, the distal segment of which is tapered. Wound on this tapered segment is a tightly coiled single strand platinum wire 25 cm in length which makes this segment radioopaque and provides steerability to the system. The final 2 cm extend beyond the central steel core. The platinum coil is soldered to the steel shaft at two points

at its proximal end called the proximal solder joint, and at three points more distally called the distal solder joint. A forming ribbon extends from the distal solder joint to the distal tip weld. The wire is coated throughout its length with Teflon.

**Figure 3.** The structure of the 0.014 inch flexible J guide wire used in the three cases (modified from USCI specifications).
